**REPORT NUMBER: 301-MGA-2009-006**

**SAFETY COMPLIANCE TESTING FOR FMVSS 301R  
FUEL SYSTEM INTEGRITY – REAR IMPACT**

**VOLKSWAGEN AG GERMANY  
2009 VOLKSWAGEN GTI  
NHTSA NUMBER: C95801**

**PREPARED BY:  
MGA RESEARCH CORPORATION  
5000 WARREN ROAD  
BURLINGTON, WI 53105**

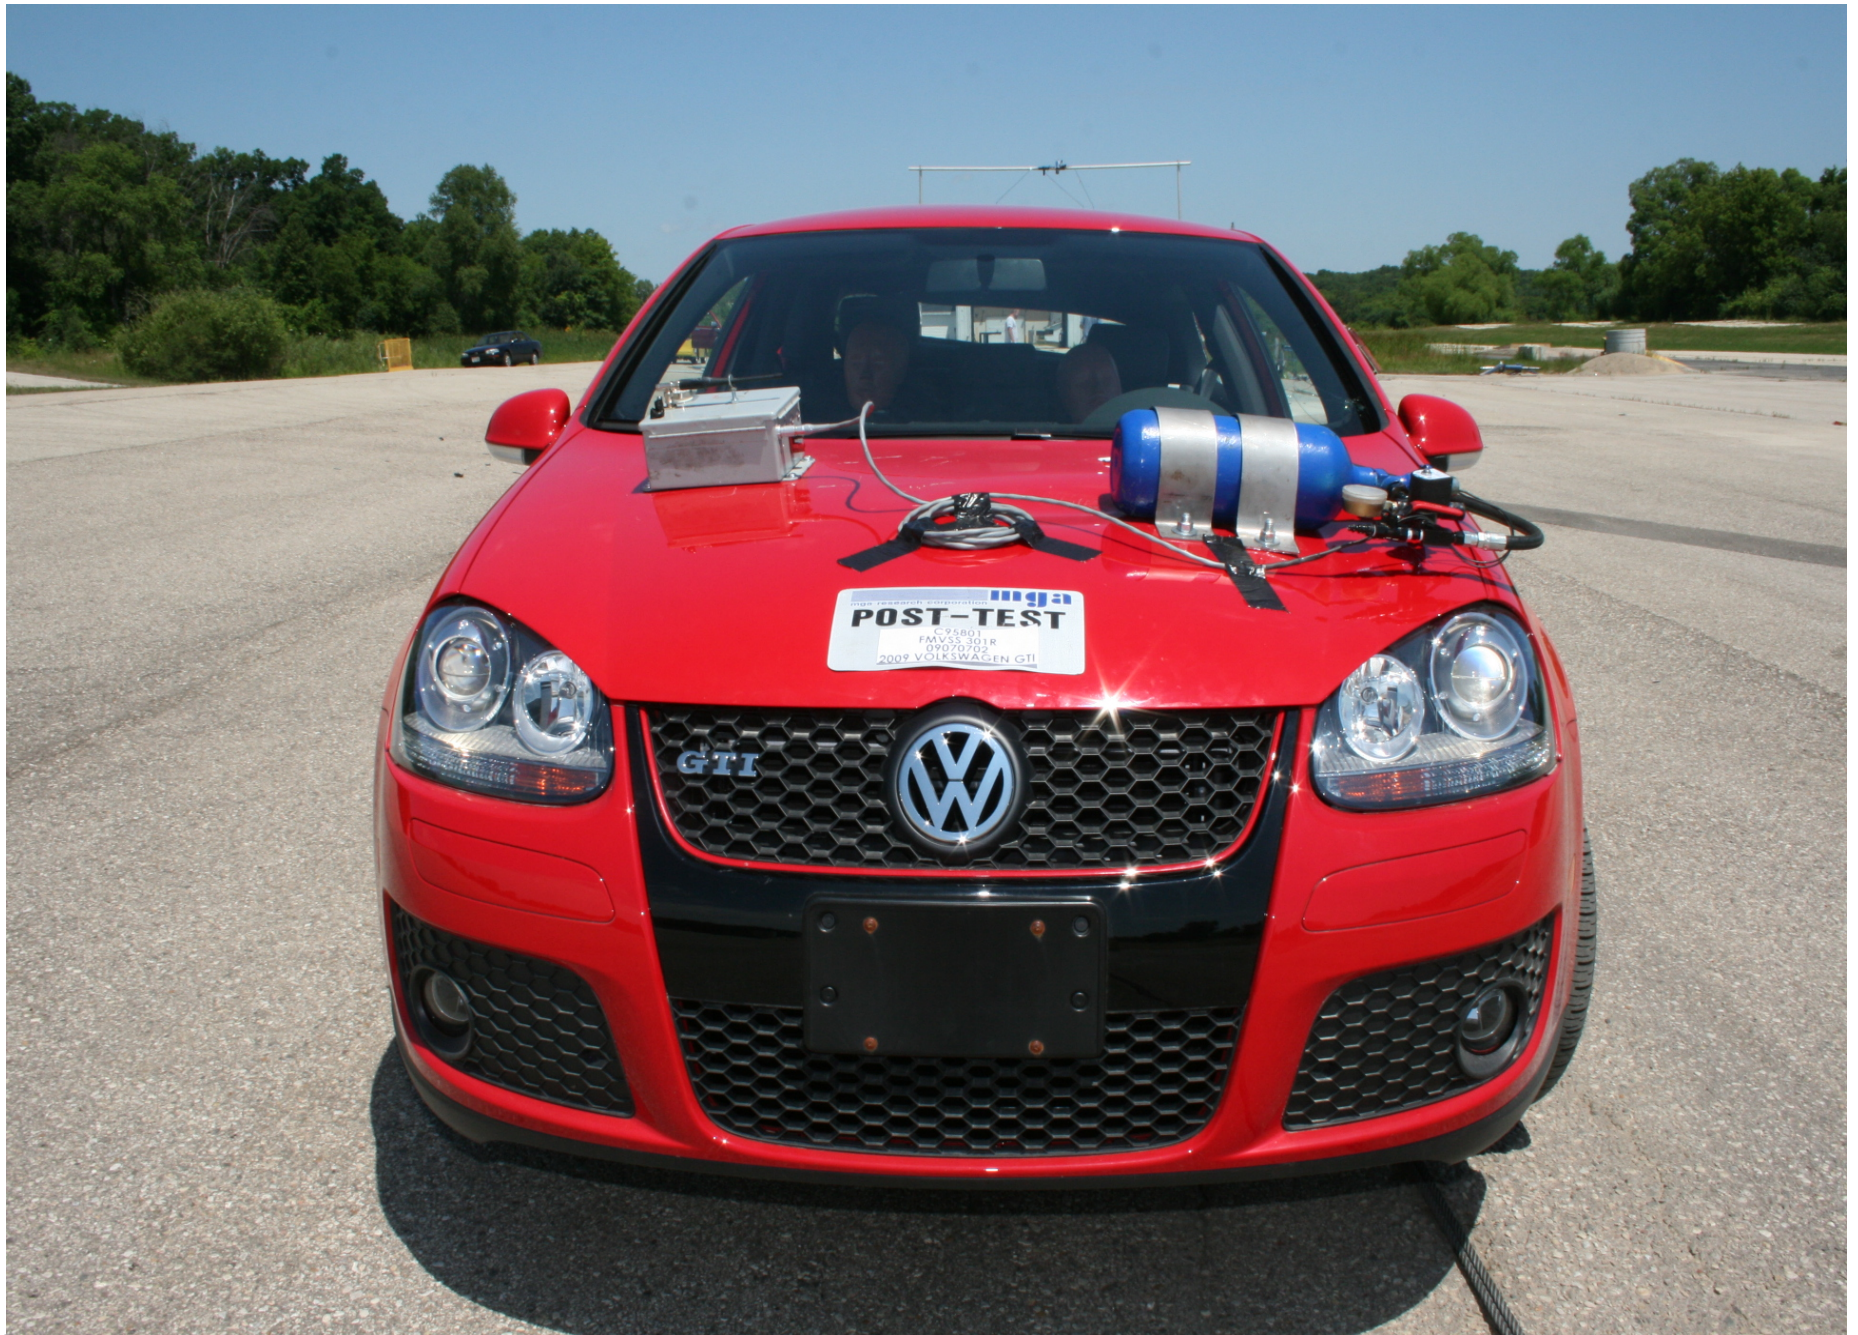
Post-Test Front View of Vehicle

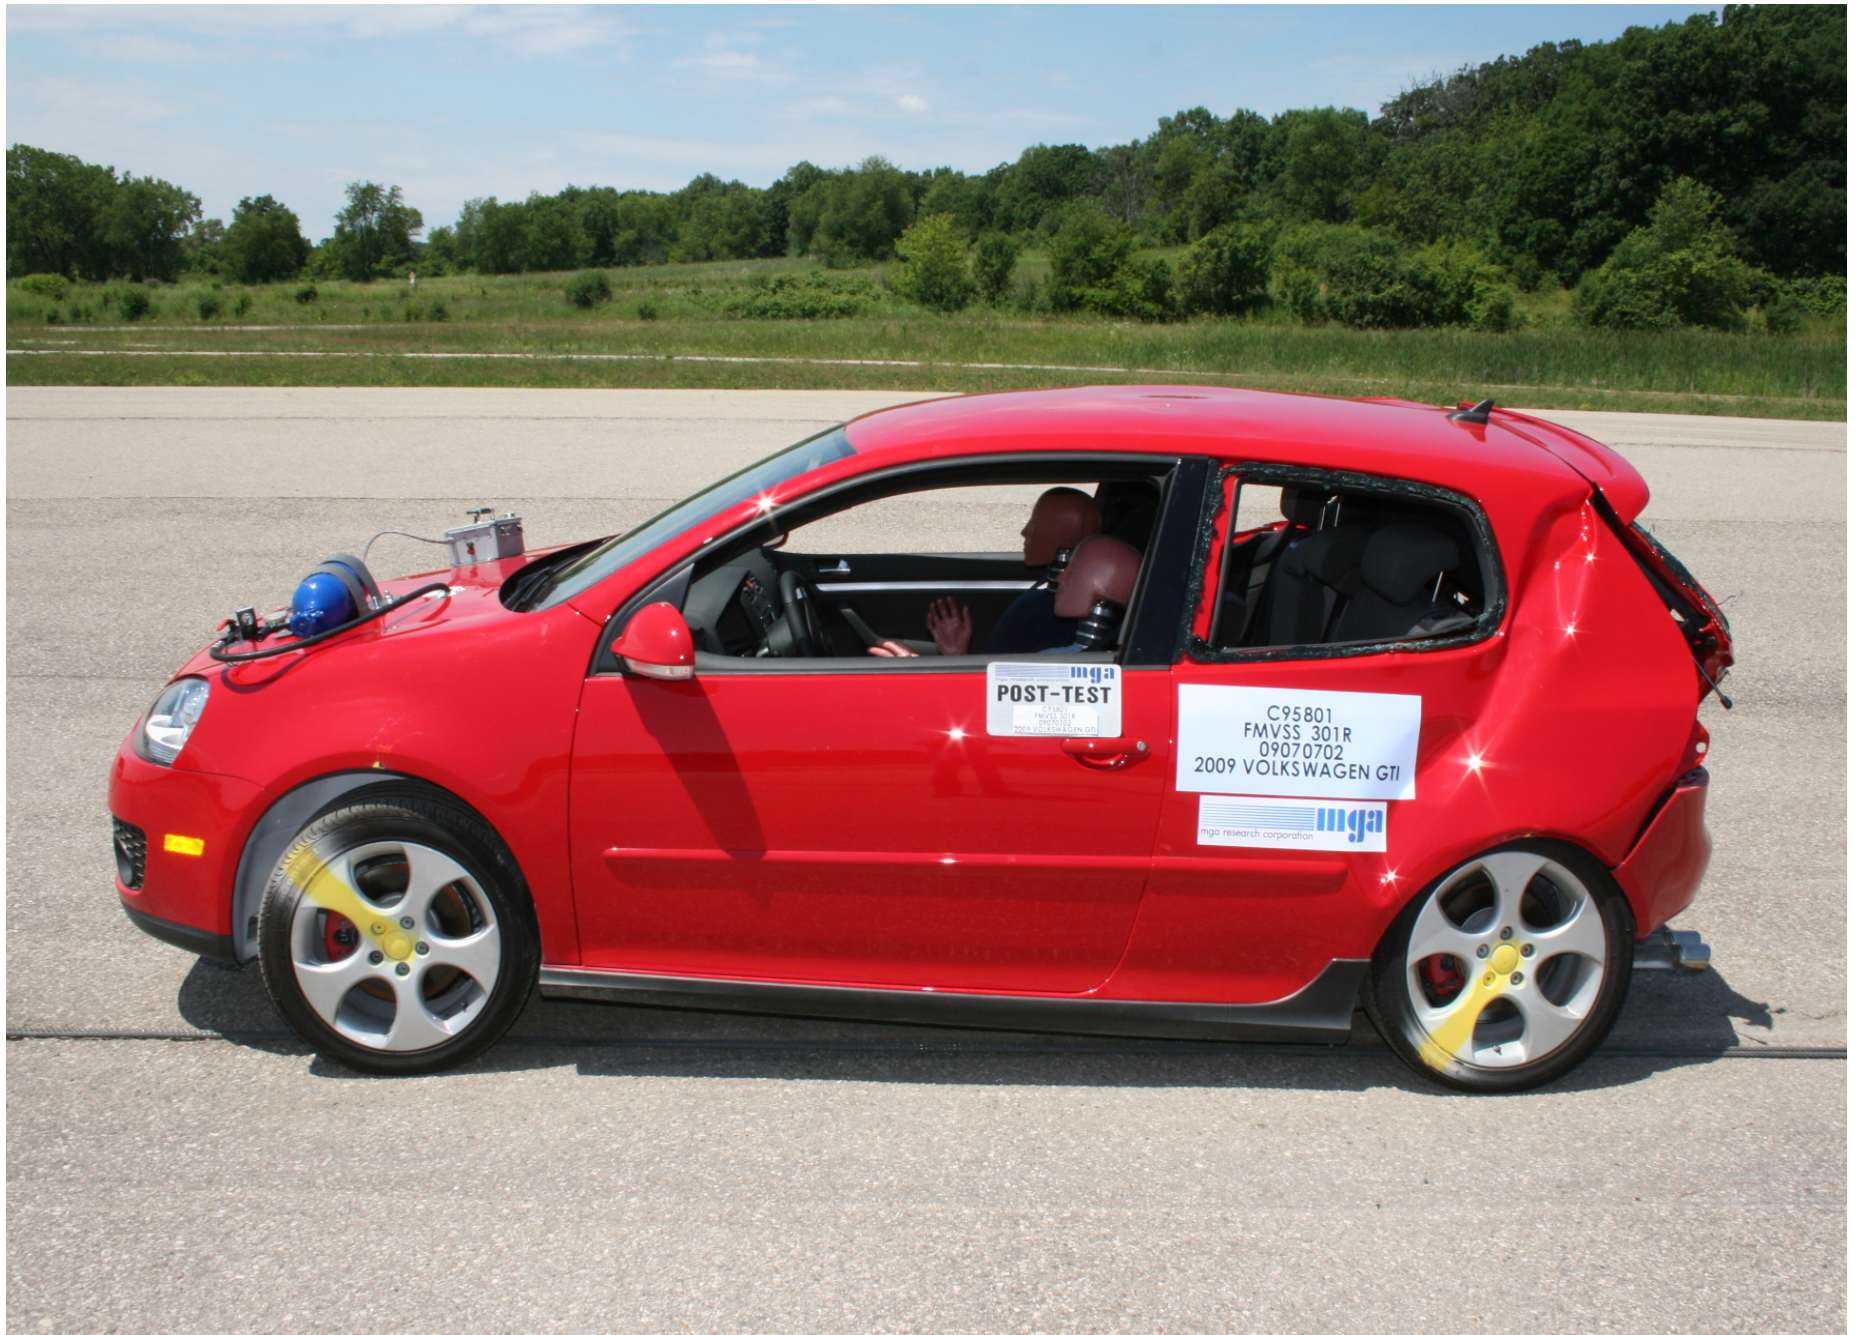
Post-Test Left Side View of Vehicle

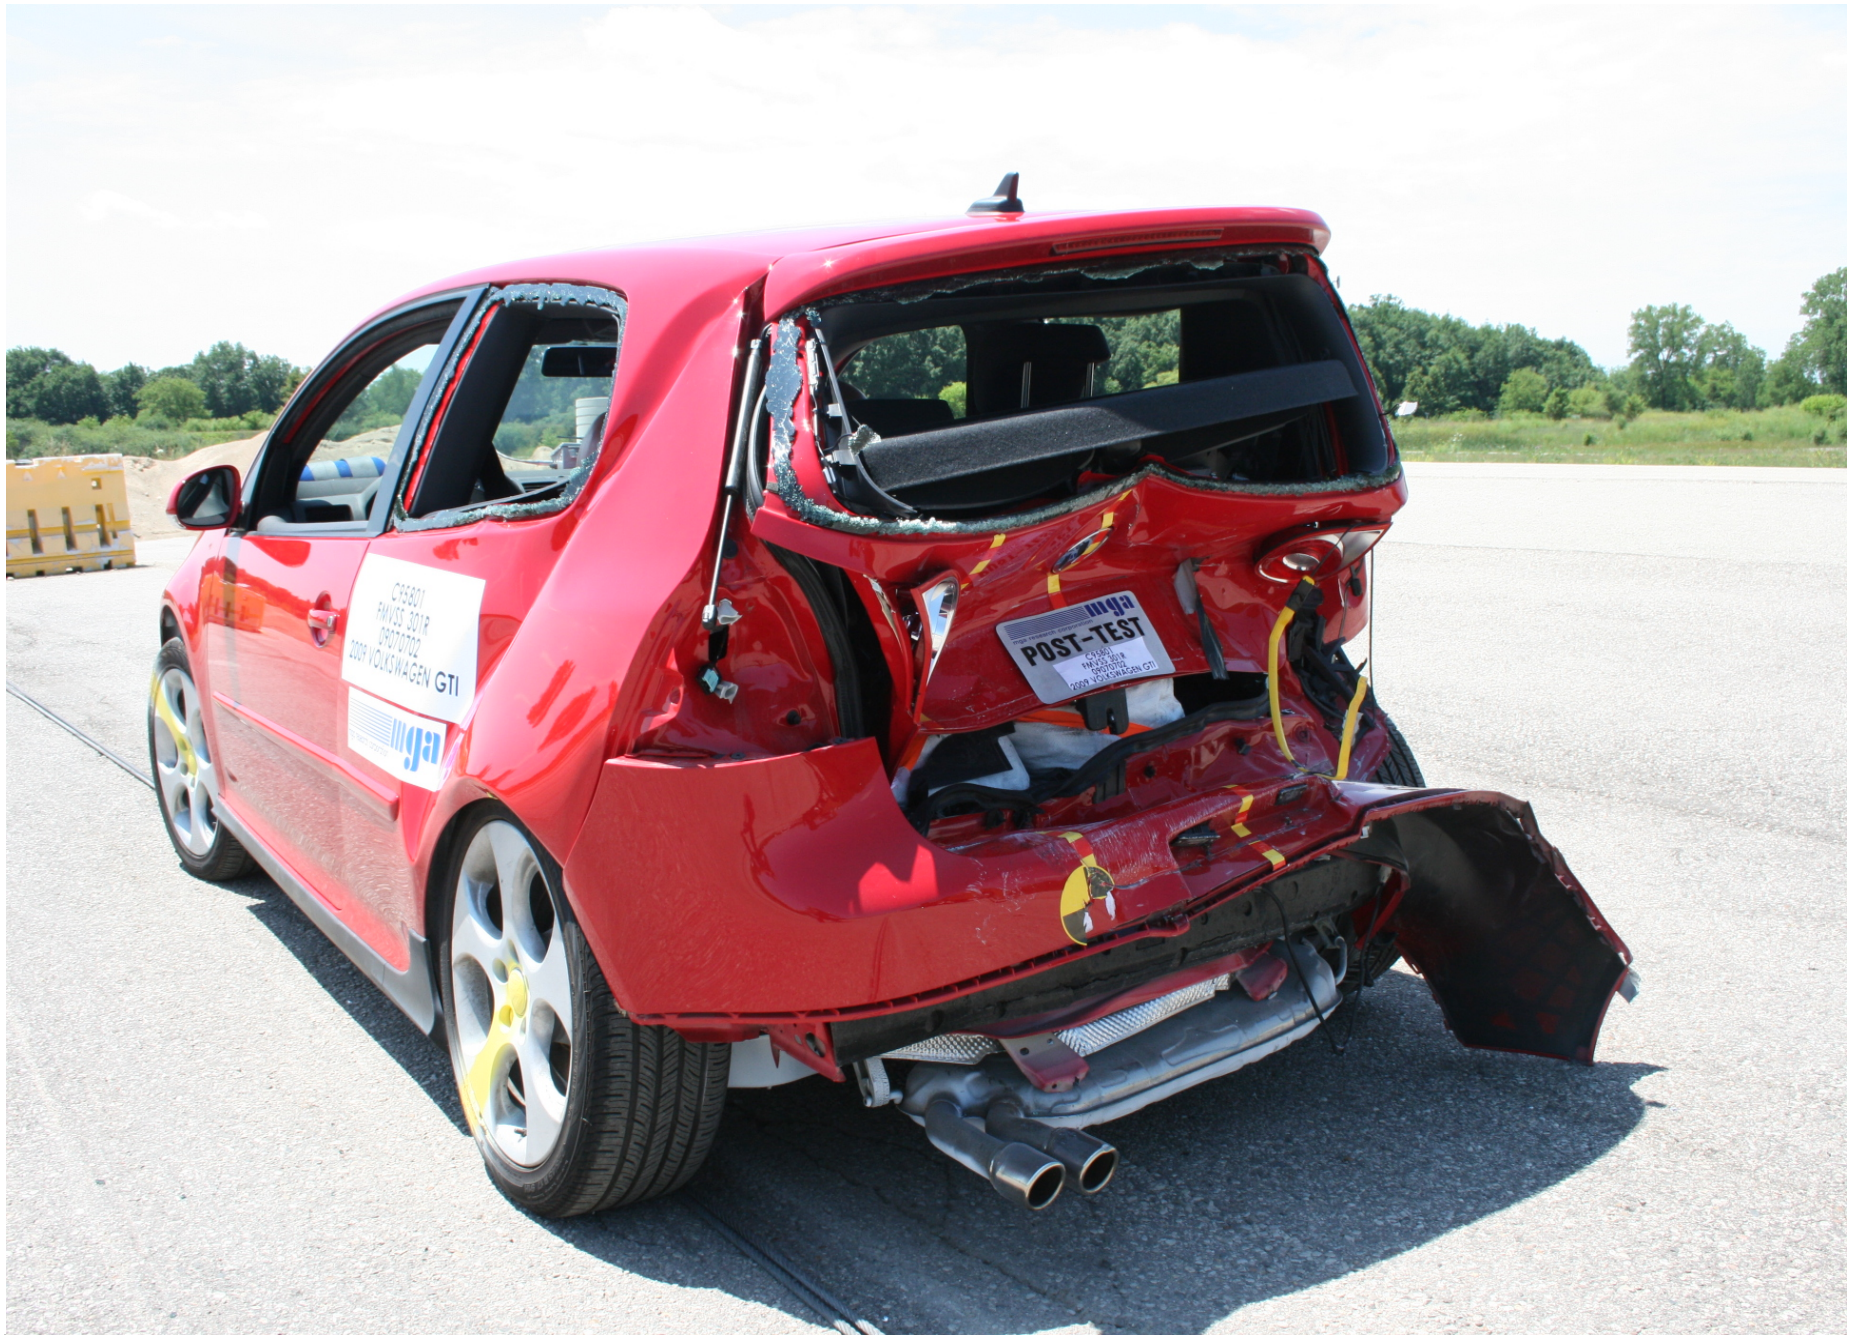
Post-Test Left Rear Close-up View of Vehicle

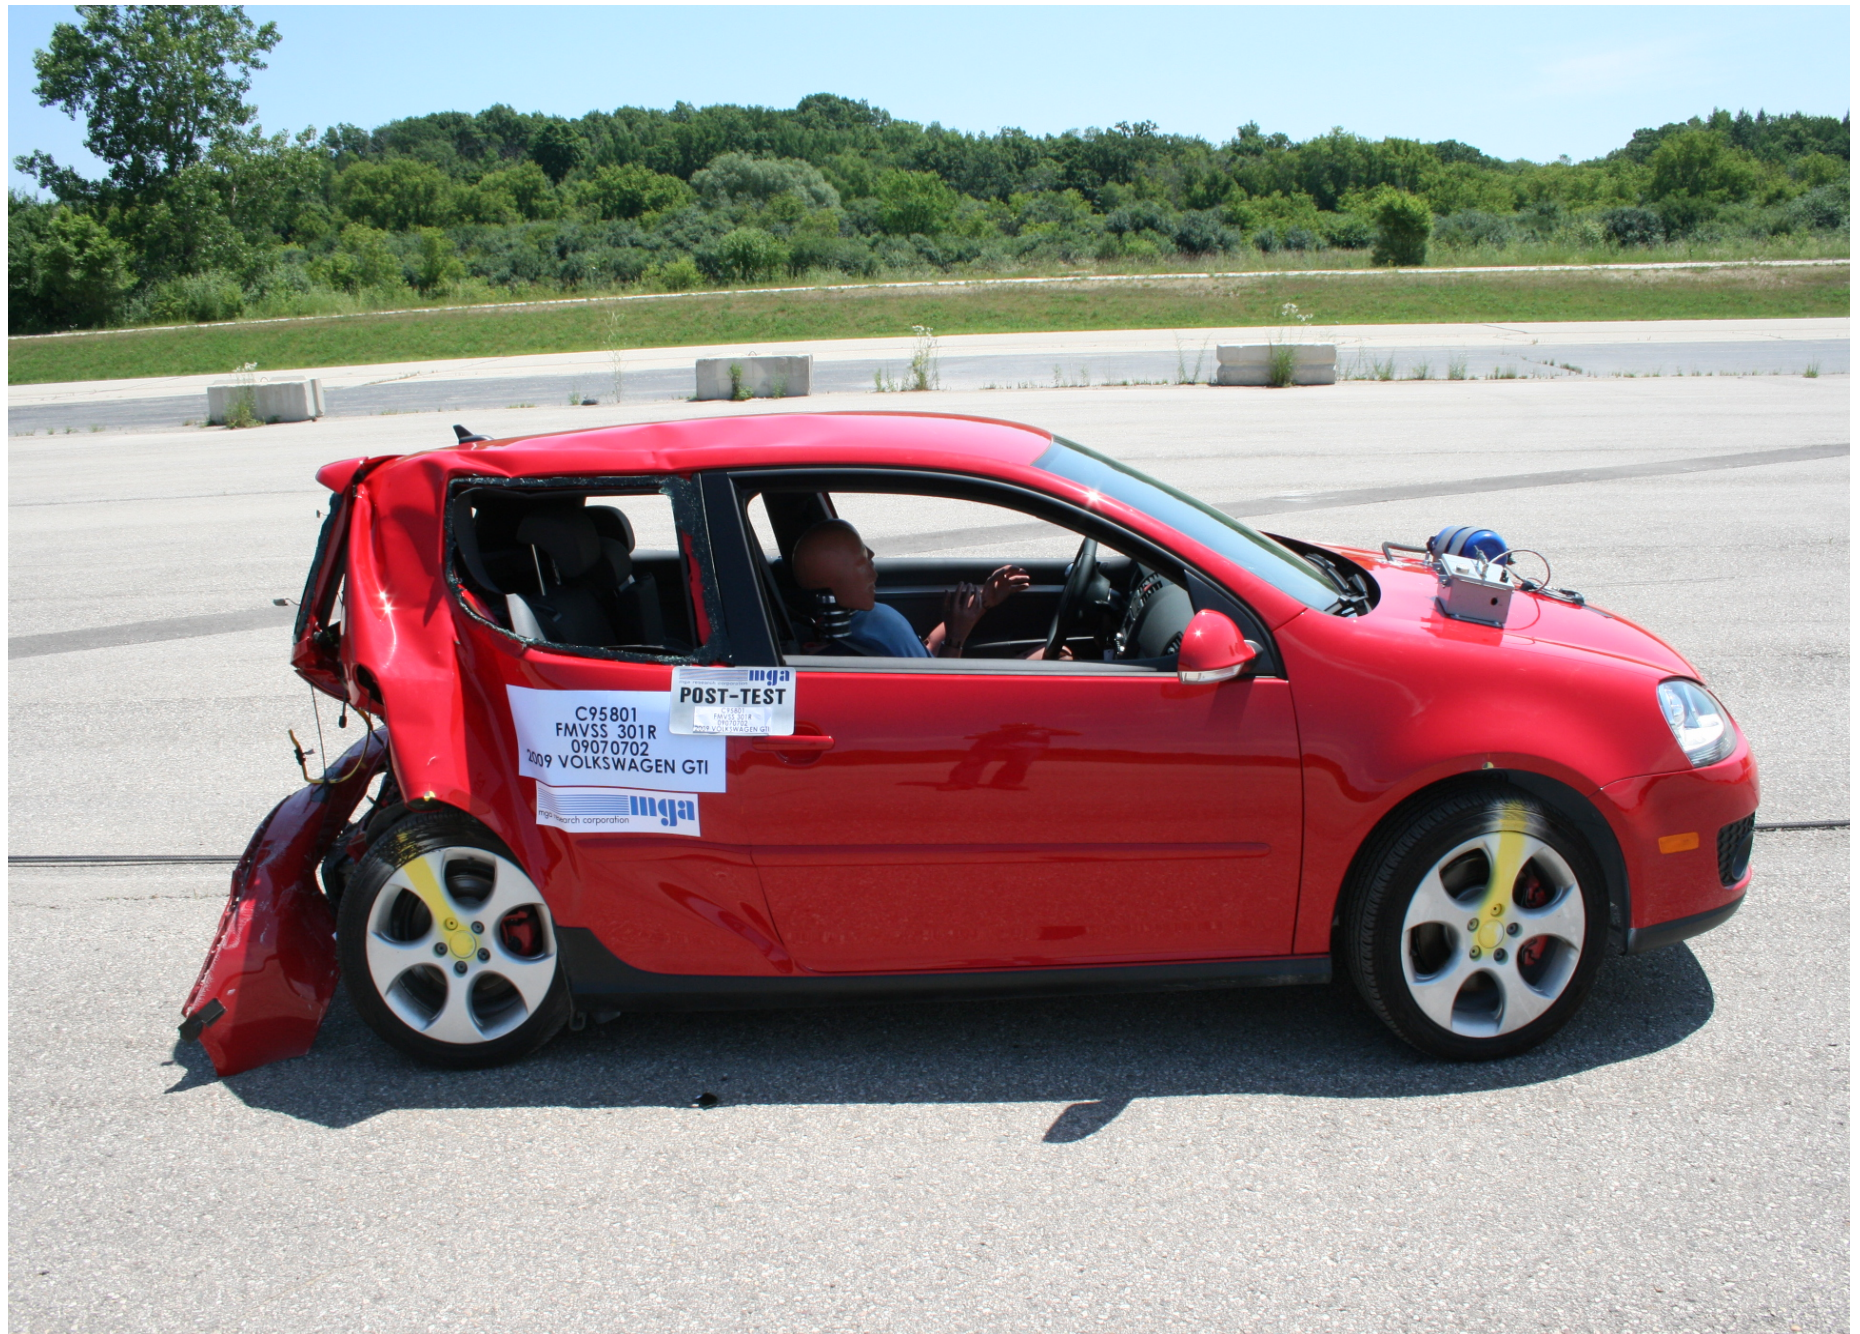
Post-Test Right Side View of Vehicle

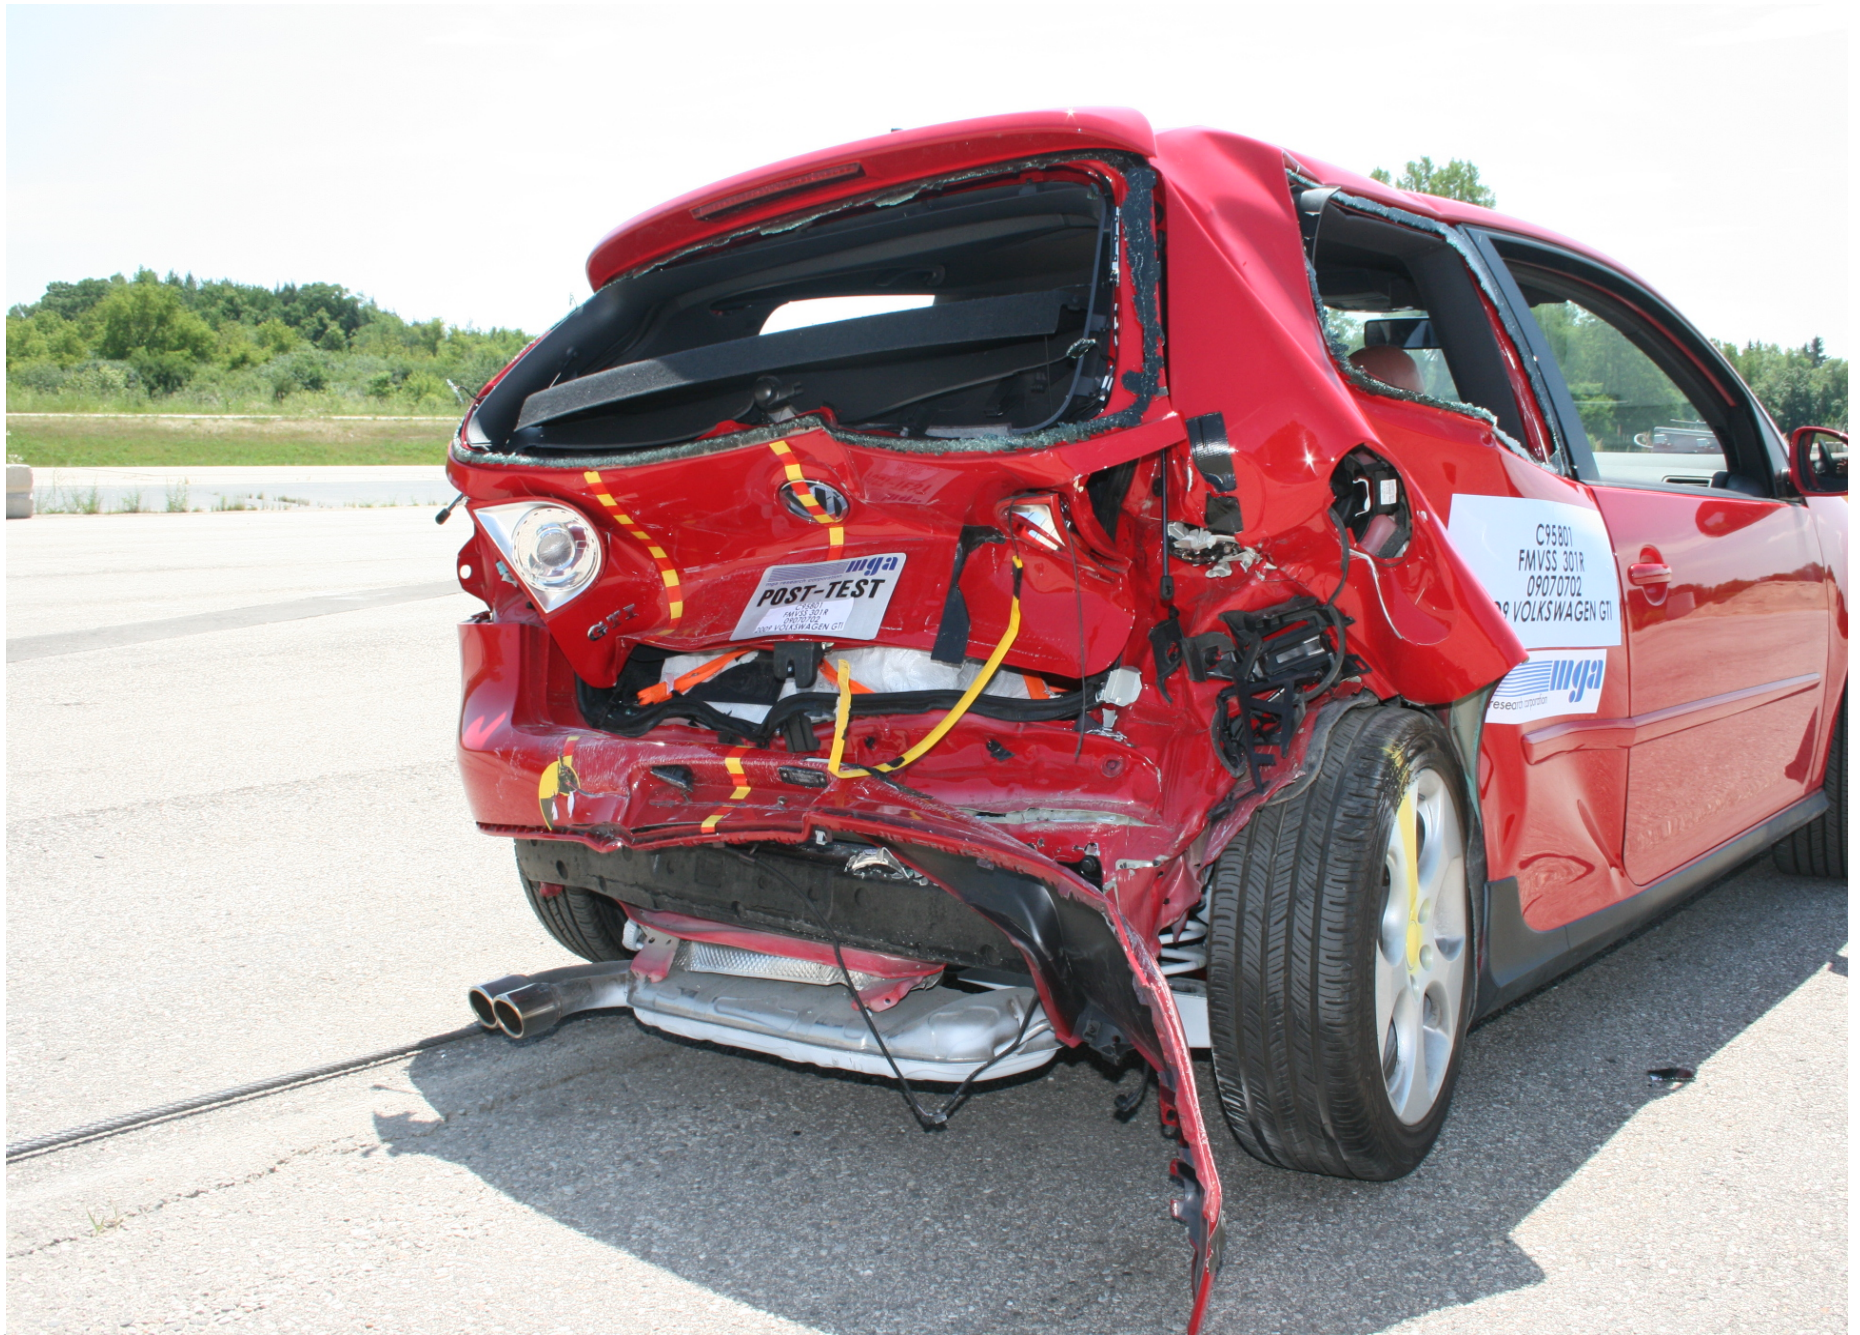
Post-Test Right Rear Close-up View of Vehicle

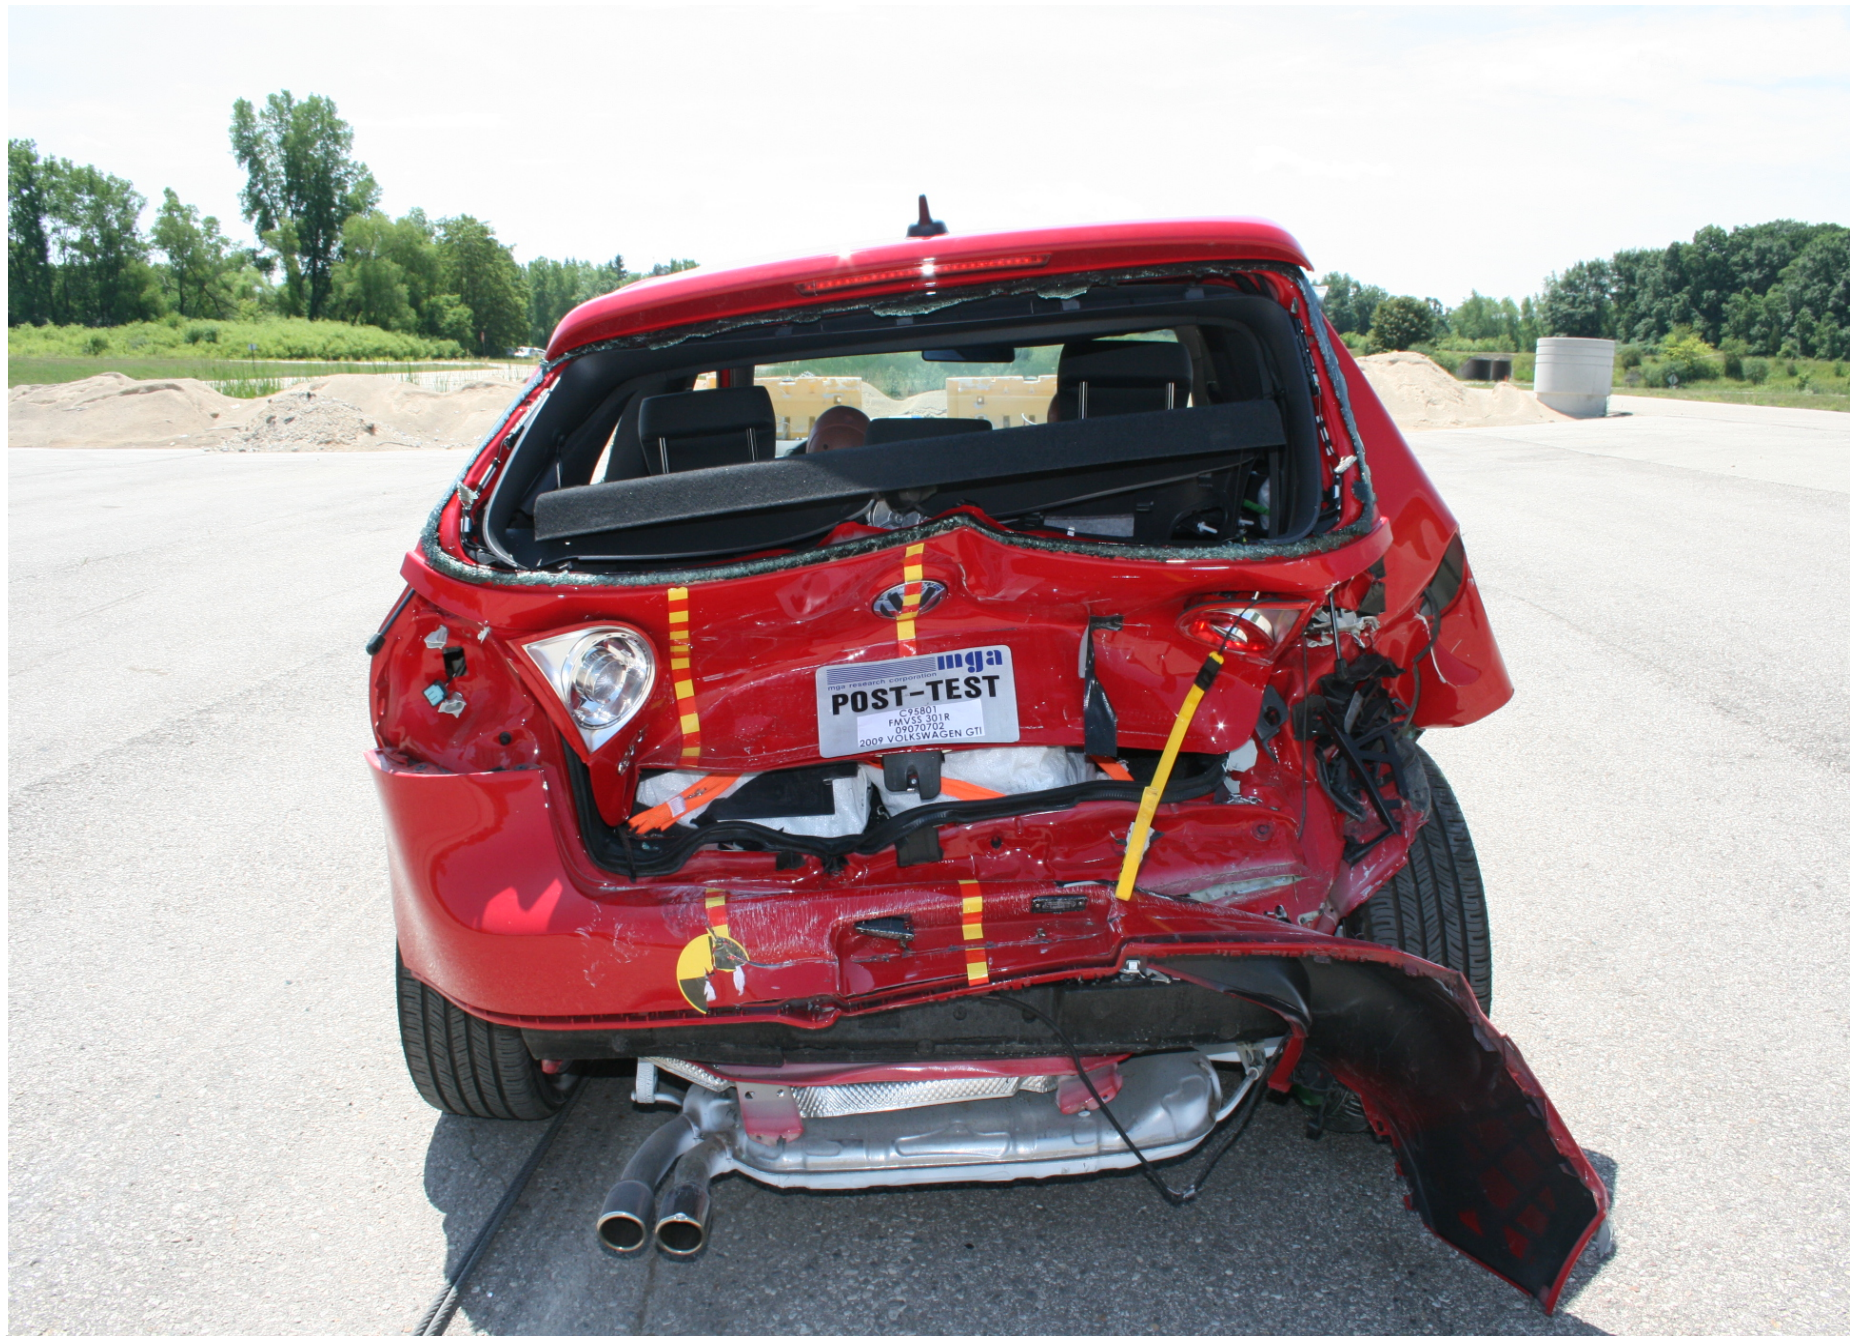
Post-Test Rear View of Vehicle

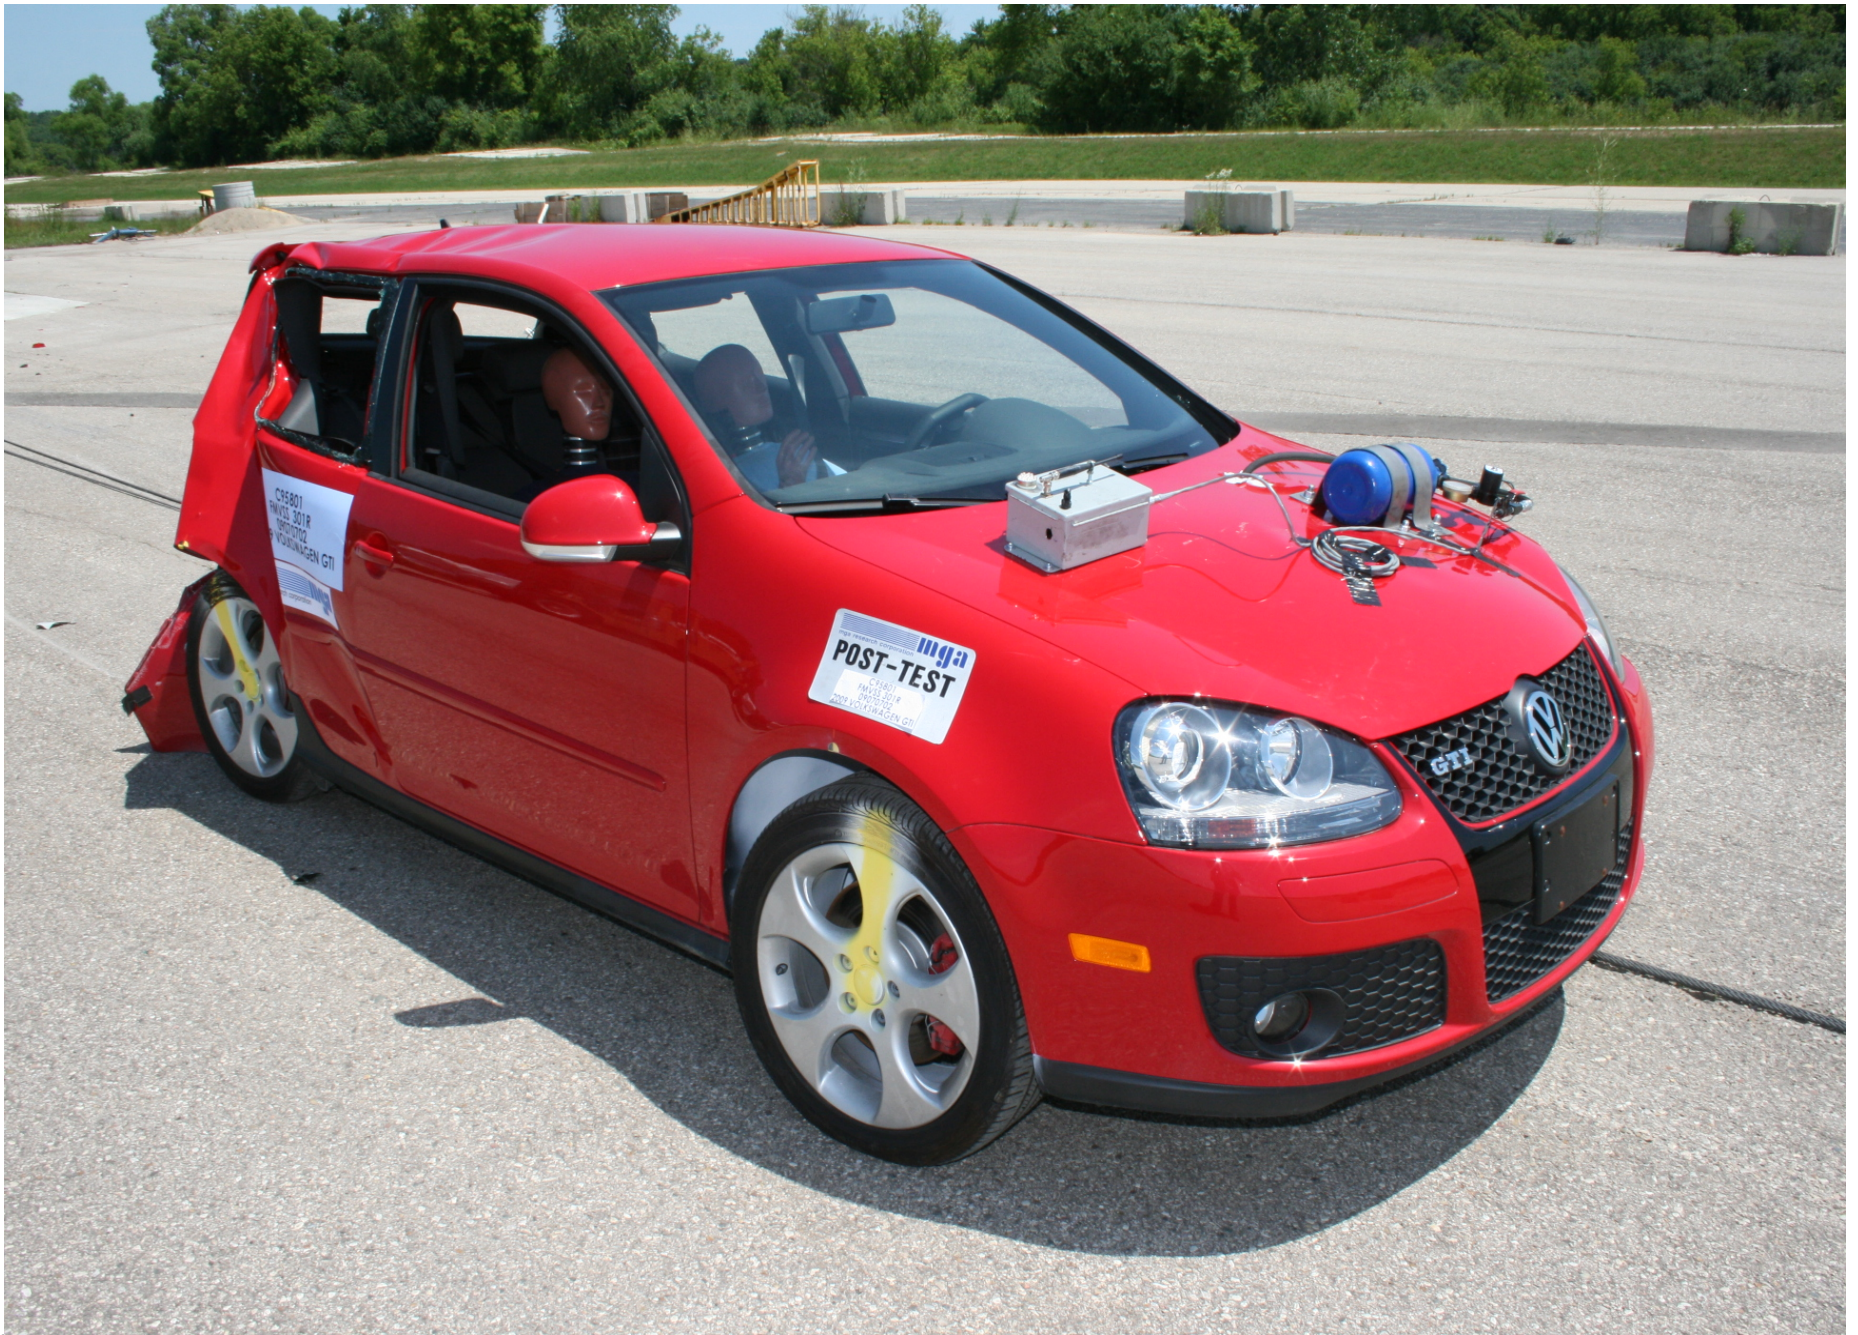
Post-Test ¾ Frontal View From Right Side of Vehicle

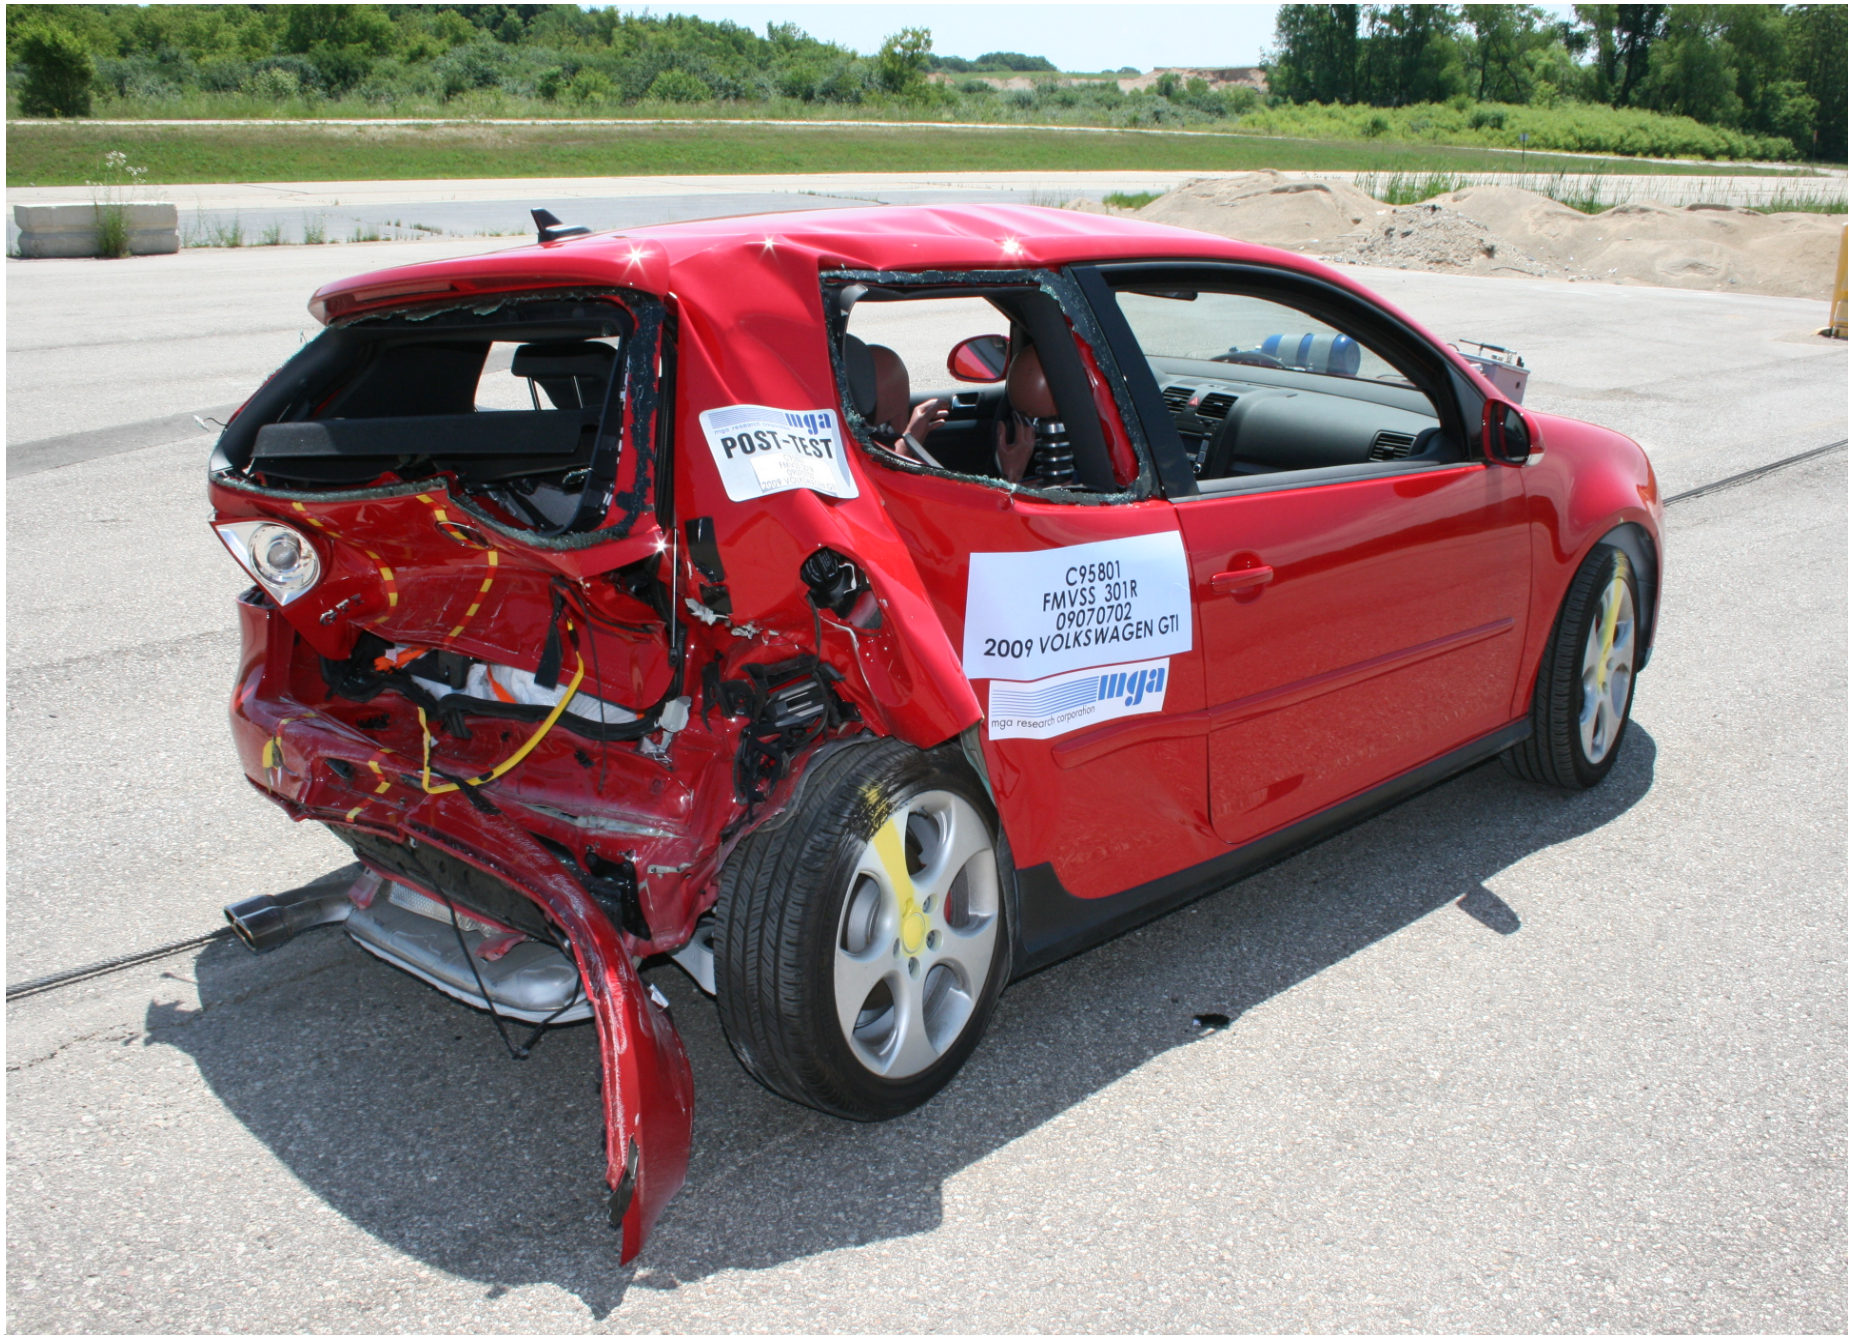
Post-Test  $\frac{3}{4}$  Rear View From Right Side of Vehicle

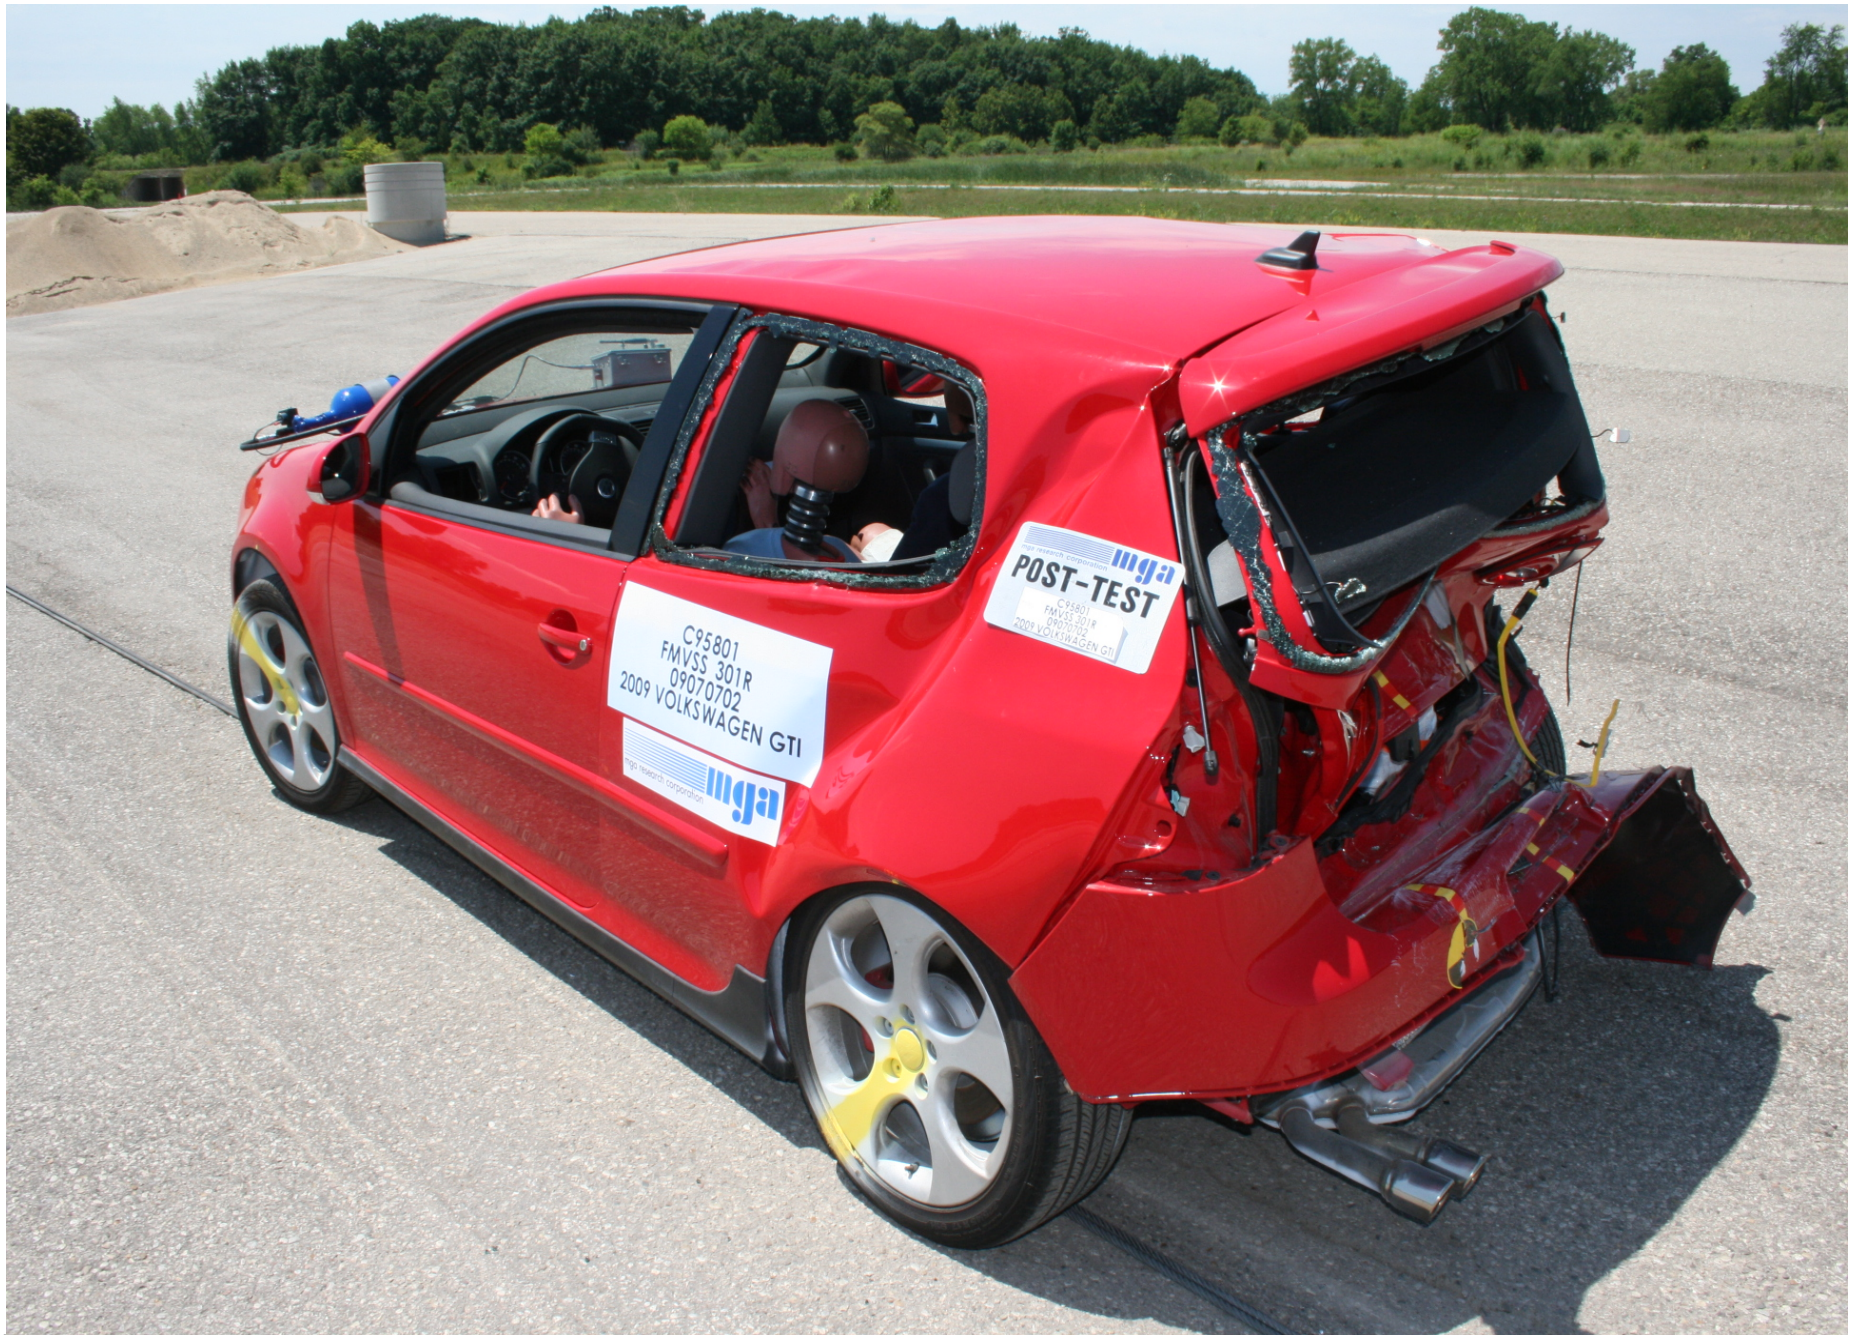
Post-Test ¾ Rear View From Left Side of Vehicle
